XCHANGER XPRESS

How to avoid internal bolt failure and fluid contamination in Shell & Tube Heat Exchangers used for sour service?

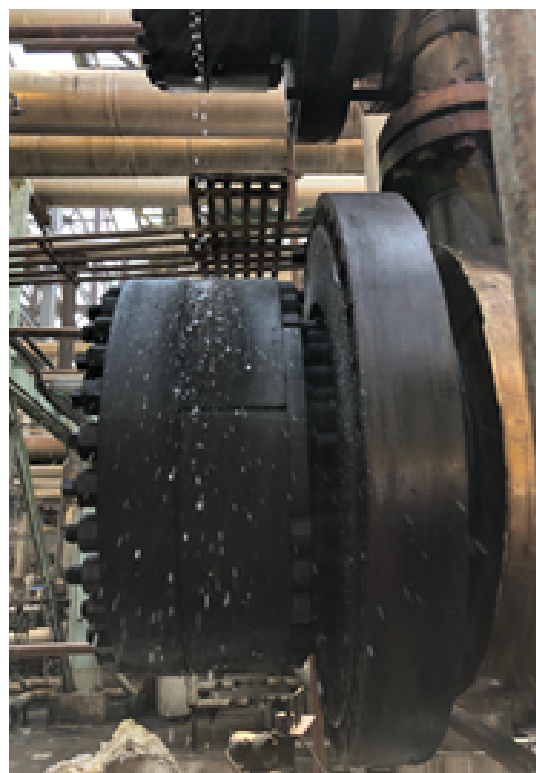
Figure-2

DHDT unit stabilizer column overhead condensers are stacked AES type exchangers. Leak was suspected in floating head cover flange and hence, shell cover was dropped. Water filling was carried out in tube side pressurized. Leak was noticed (as shown in the figure-2) from the floating head flange due to shearing of B7 bolts (4 nos). Mix up of two grades was evidenced. ASTM A193 Gr B7 bolts were found in place of ASTM A193 Gr B7M bolts and hence, all Gr B7 bolts were replaced with Gr B7M bolts. Also, the gasket was replaced and tube and shell side hydro test was carried out and taken into service.

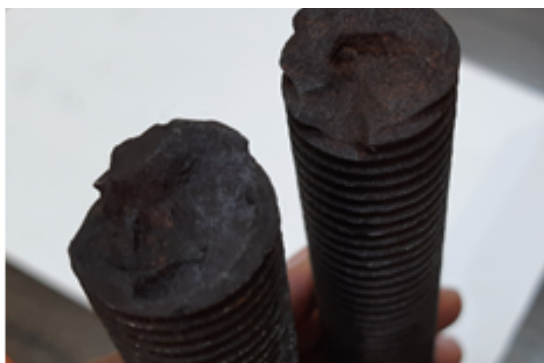
Figure-3

Propane De-Asphalting (PDA) unit has propane condensers to condense propane vapor in De-Asphalted oil recovery section. Considering absence of H₂S content in propane, AES S&T condensers were designed with ASTM A193 Gr B7 floating head bolts as mentioned in Bill of Materials (BOM) of exchanger general arrangement drawing. Yet, floating head bolts were sheared in-service. It was analyzed and found that H₂S slippage in to shell side stream had caused the brittle failure of high hardness bolts (As shown in figure-3&4). All Gr B7 bolts were replaced with Gr B7M with new gasket, and equipment was hydro-tested and taken into service.
